HomePro Home Inspections
PO Box 6261
Rochester, MN 55903

941 10th Avenue NE
Rochester, MN 55906

Maintenance Summary

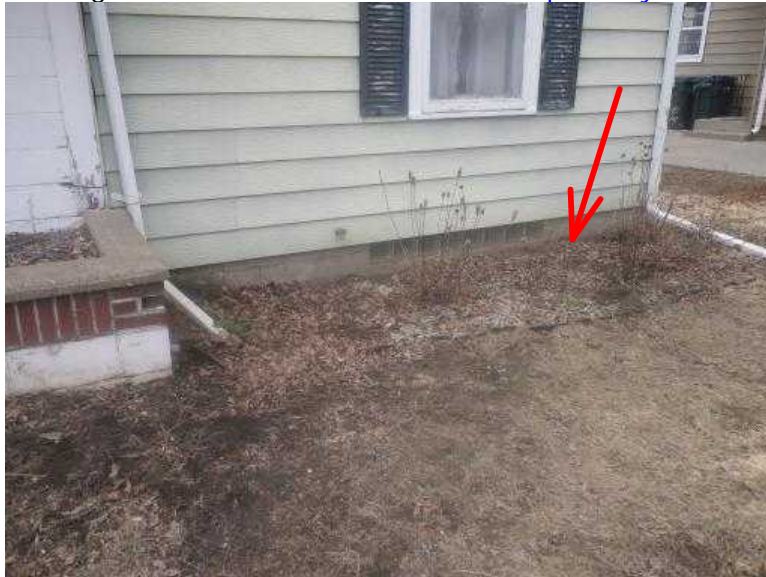
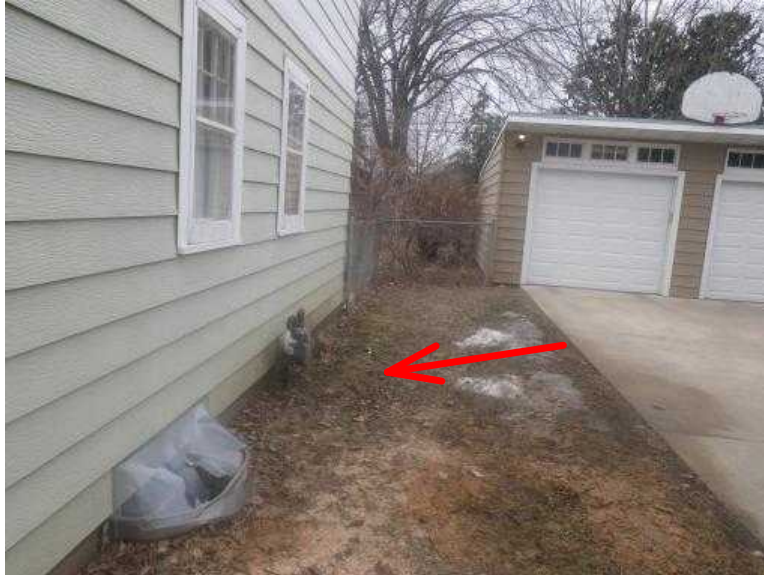
| 8. Repairs Recommended | Grading: Level Site - Recommend soil slope away from structure |

1. Grading: Level Site - [Recommend soil slope away from structure](#)

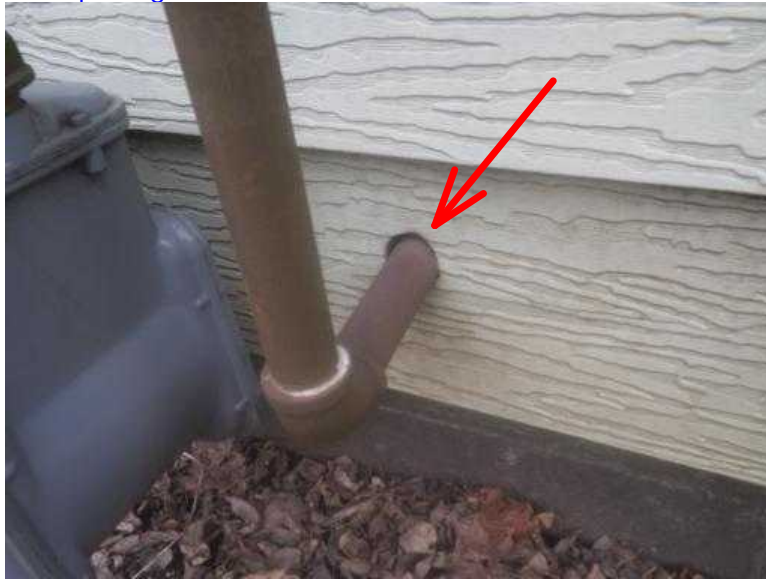
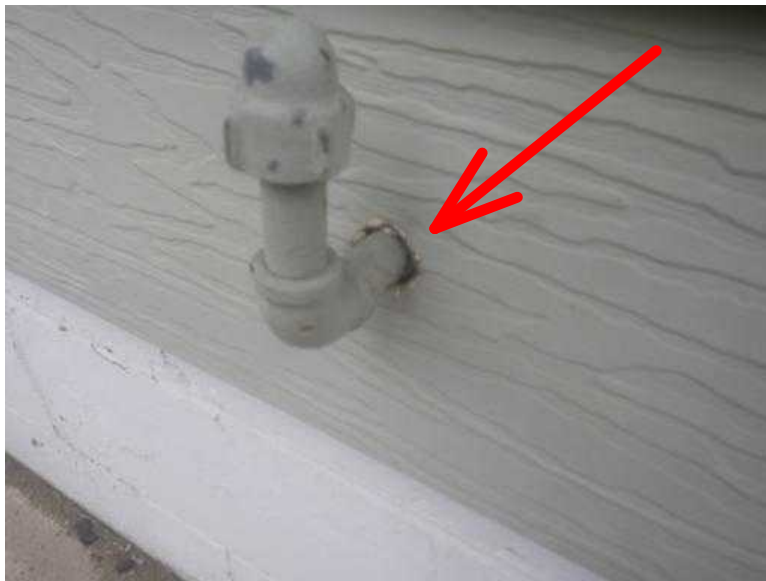
1. Repairs Recommended Exterior Walls: Wood frame, Metal siding, Common cracks - [Recommend sealing cracks and openings at exterior](#)

2. Exterior Walls: Wood frame, Metal siding, Common cracks - [Recommend sealing cracks and openings at exterior](#)
3. Gutters/Downspouts: Fully installed - [Gutters debris filled, recommend cleaning gutters, Loose, missing downspouts at north west side](#)

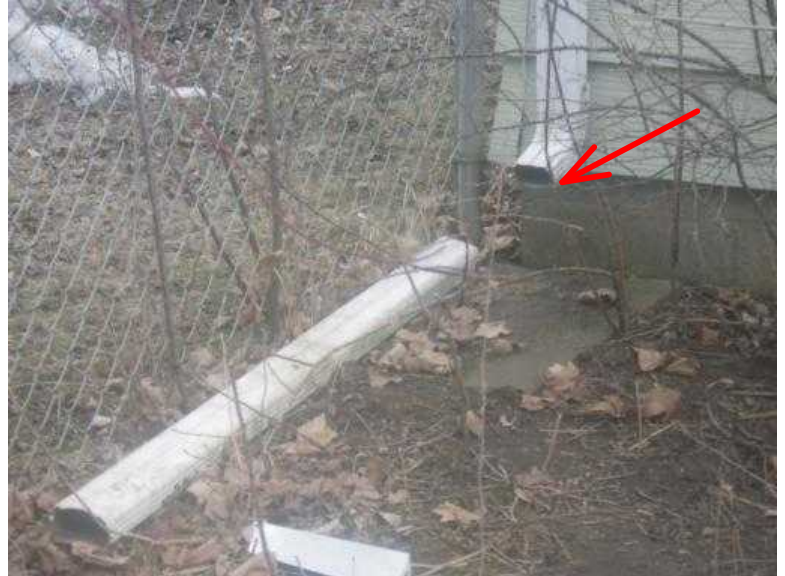
4. Repairs Recommended Gutters/Downspouts: Fully installed - Gutters debris filled, recommend cleaning gutters, Loose, missing downspouts at north west side

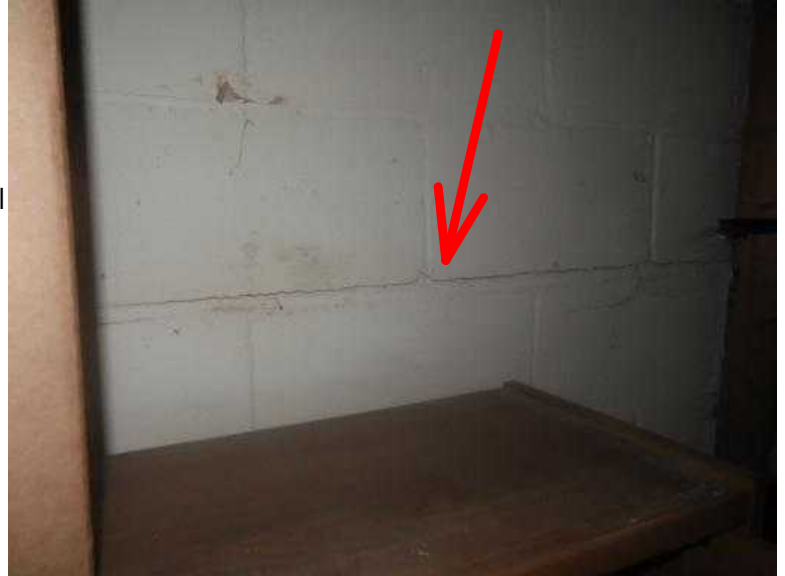
Foundation Material:
Masonry block, Common
cracks, Basement walls not
fully visible - Note - Step
crack noted at foundation
wall at north side, Horizontal
crack at foundation wall at
north side - Monitor

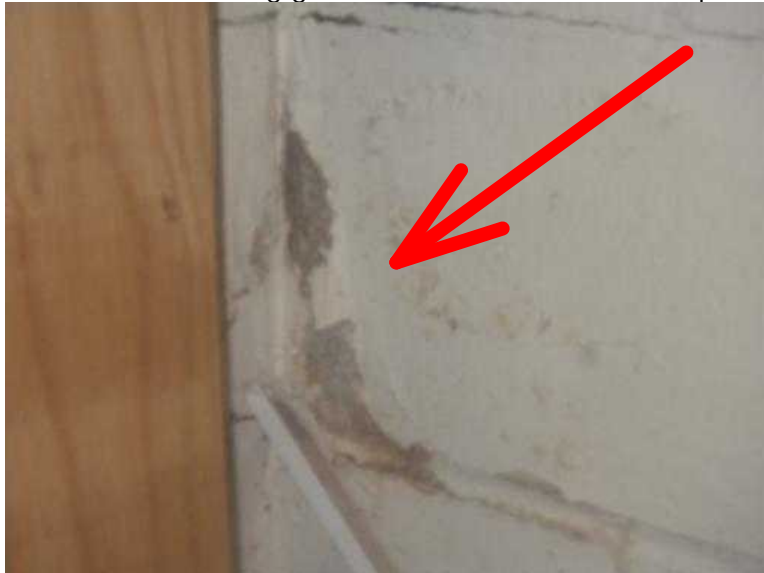
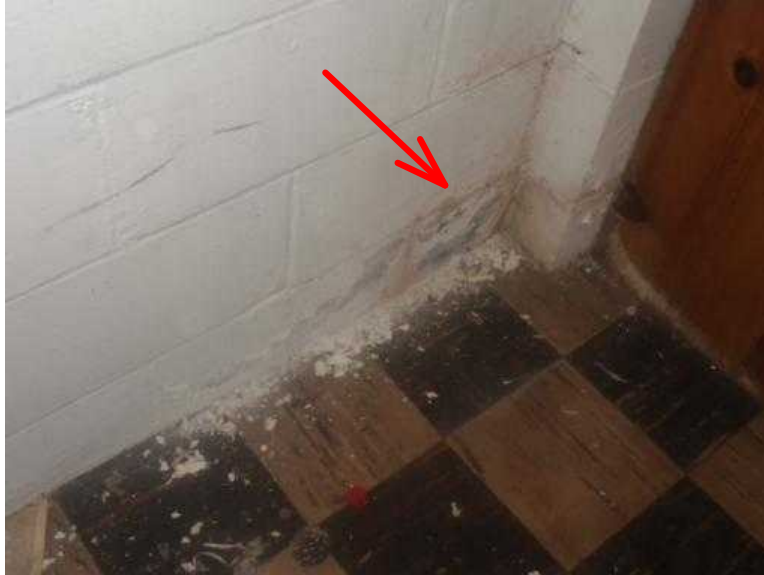
Basement is: Full, partially finished, Basement stairs acceptable, Hand railing acceptable
- Moisture stains (dry) at north east corner and south basement wall - - Note -
Recommend cleaning gutters and recommend soil slope away from foundation

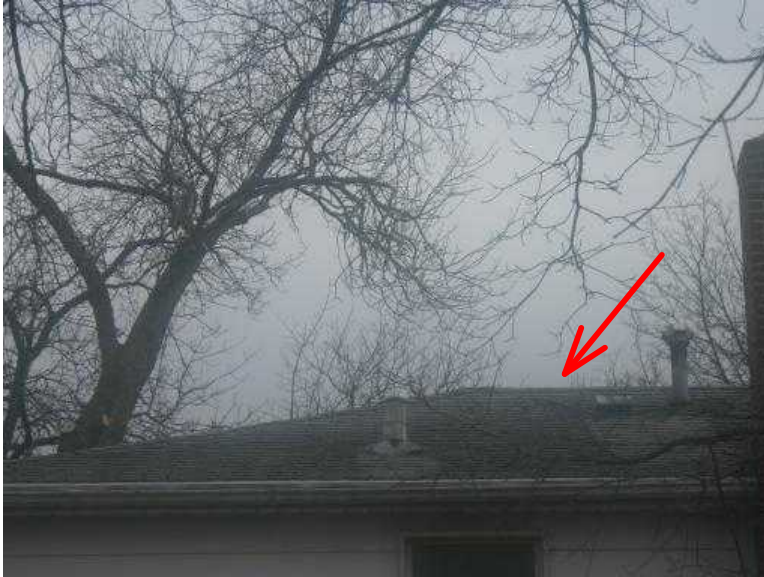
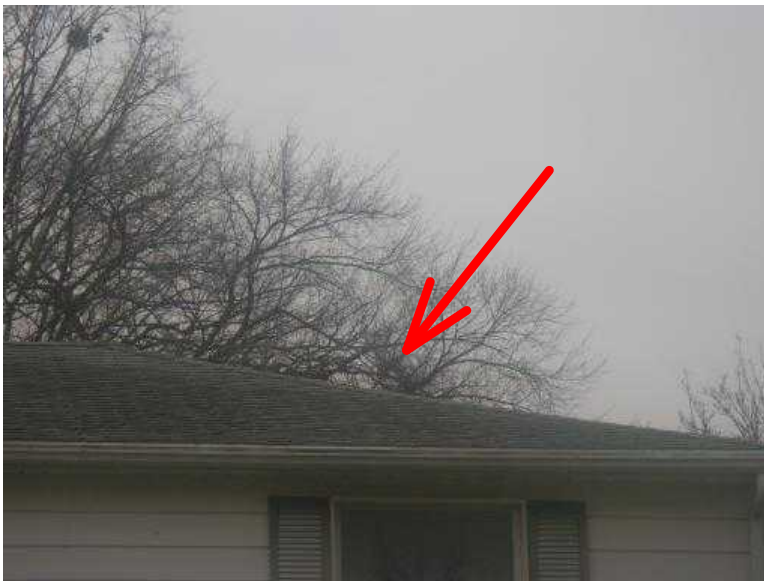
Material: Asphalt shingle - Roof is showing signs of weathering and aging - Typical for age of roof - Monitor

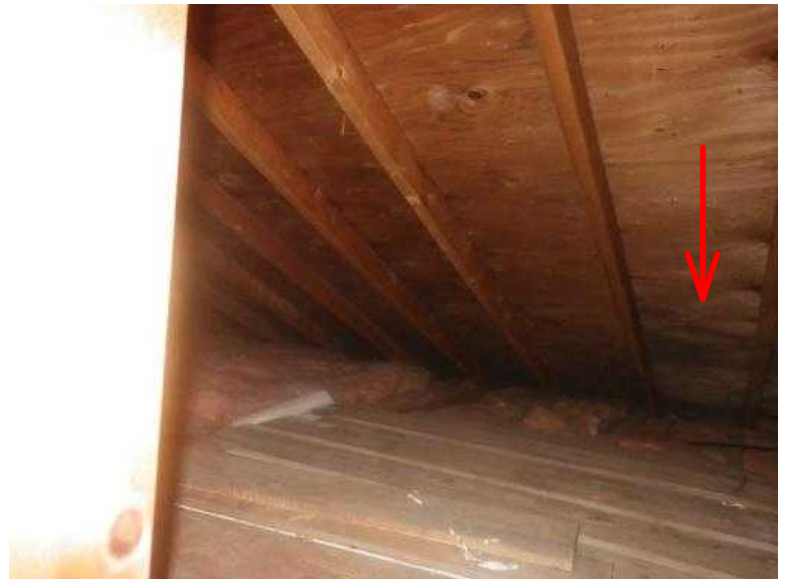
1. Method of Inspection: Inspection limited to view from access
2. Acceptable Roof Framing: Rafter
3. Acceptable Sheathing: Plywood -
Discoloring noted due to moisture on roof sheathing -
Sheathing is not damaged -
Attic space could benefit from more venting

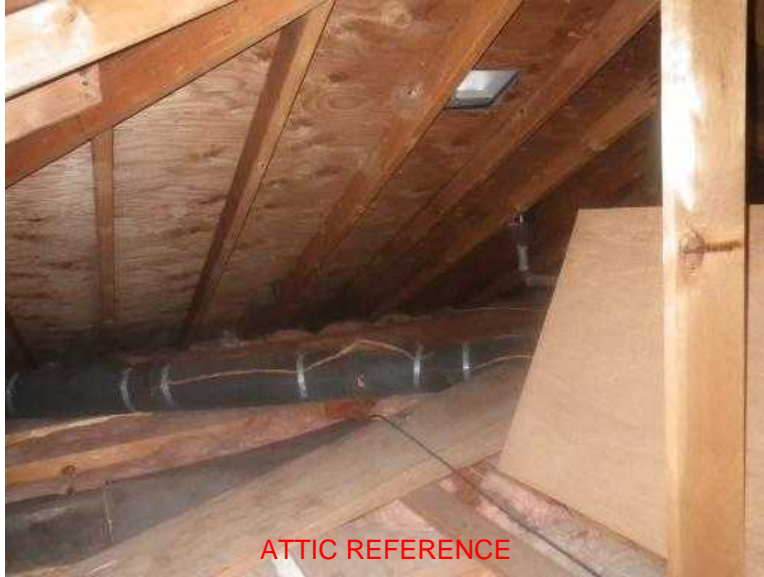
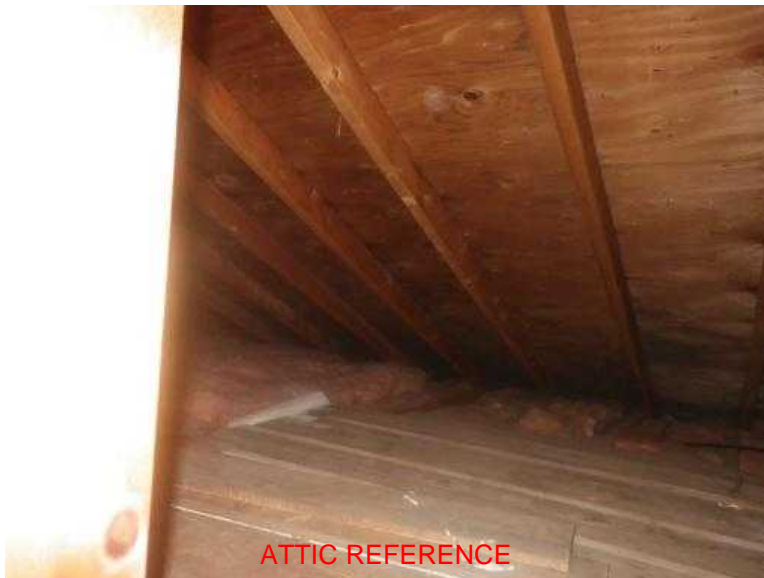
Insulation: Fiberglass batts - ~ 6 to 8 inches of insulation present - Recommend additional insulation be installed

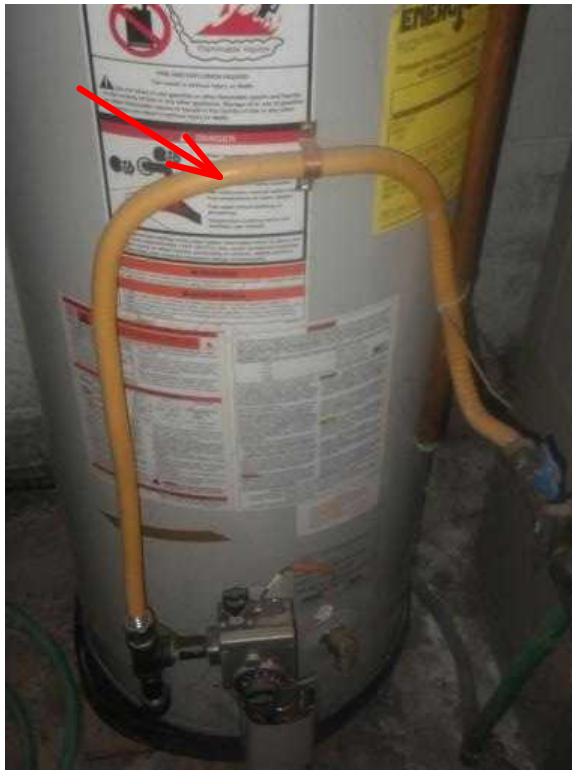
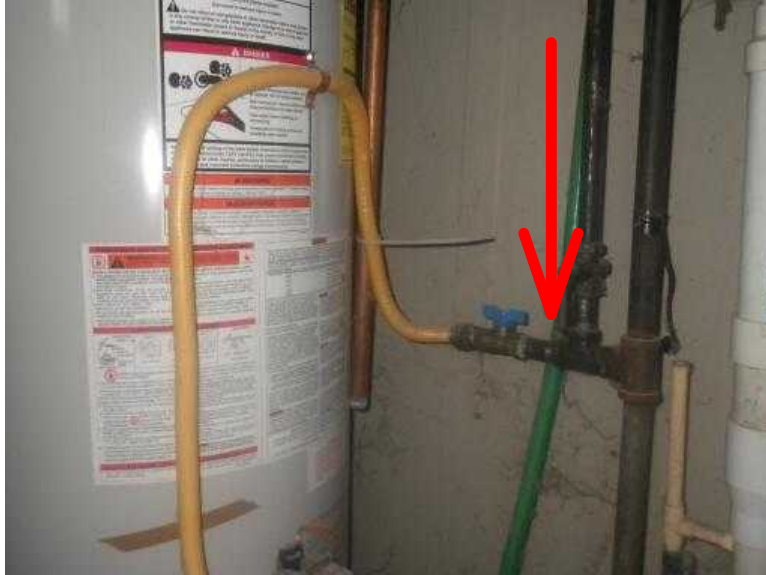
1. Acceptable Service Line: Copper
2. Acceptable Main Water Shutoff: Basement
3. Acceptable Water Lines: Copper
4. Acceptable Waste Lines: PVC, Cast iron, Copper
5. Not Present Water Softener
6. Acceptable Gas Meter: Right side
7. Acceptable Main Gas Valve: Located at gas meter
8. Repairs Recommended Gas Service Lines: Copper, Black pipe, CSST - [Recommend properly bonding CSST gas line and provide proper clearance/insulation from adjacent metal surfaces at water heater](#)

4. Gas Service Lines: Copper, Black pipe, CSST - [Recommend properly bonding CSST gas line and provide proper clearance/insulation from adjacent metal surfaces at water heater](#)
5. Basement Water Heater TPRV and Drain Tube: [Drain tube opening is not within six inches of the floor](#)

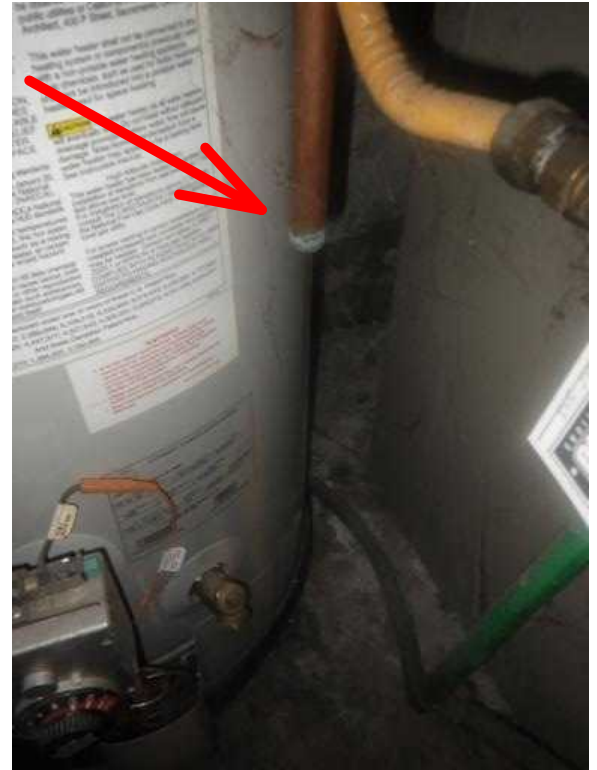
14. Repairs Recommended TPRV and Drain Tube: [Drain tube opening is not within six inches of the floor](#)

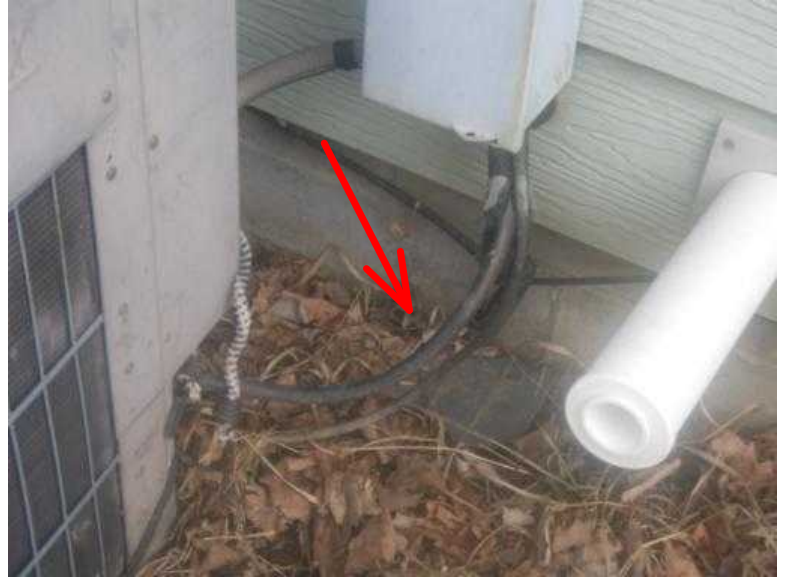
3. Repairs Recommended Refrigerant Lines:
Deteriorated Insulation

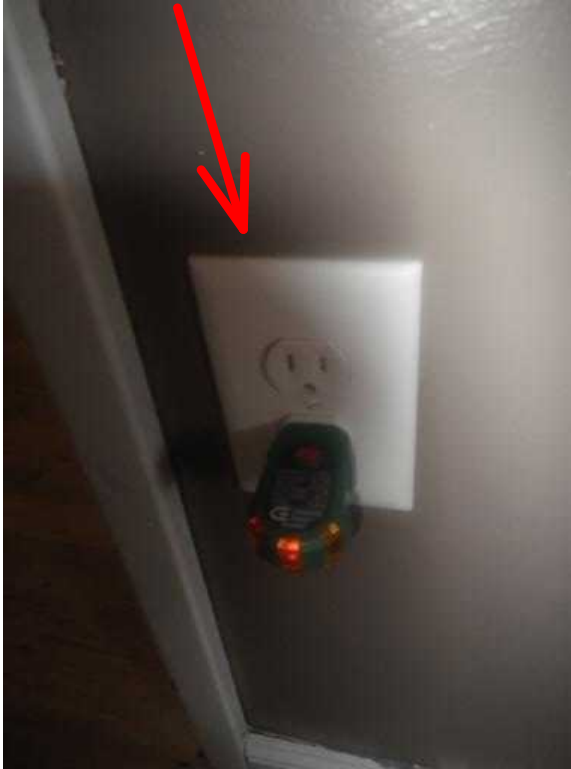
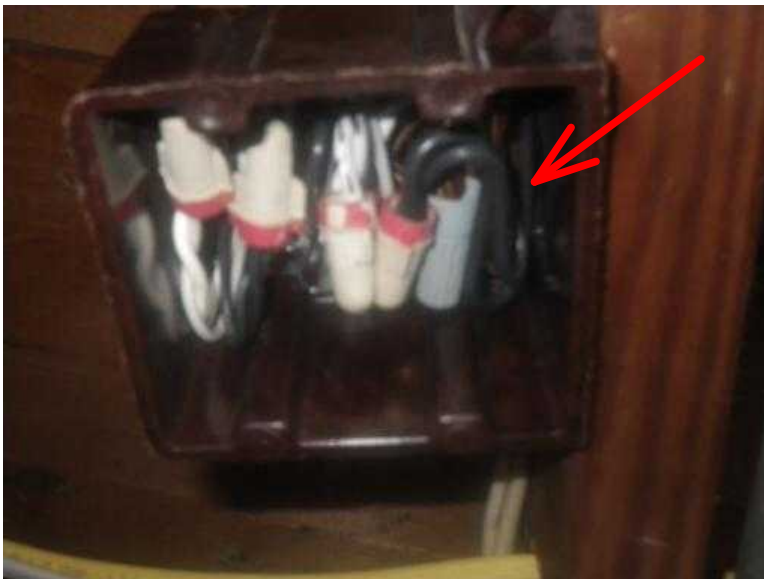
6. Repairs Recommended Wiring Notes: Outlet has Hot/Neutral reversed near kitchen - To the right of door way going into kitchen, Junction box missing cover in basement near electrical panel, 3-prong outlets did not test properly, (open ground) at main level outlets - Recommend installing GFCIs at outlets that will be used the most

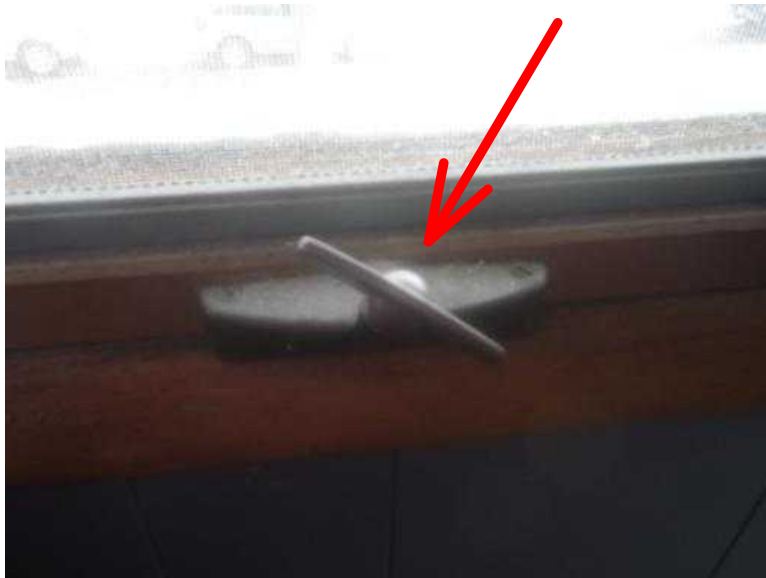
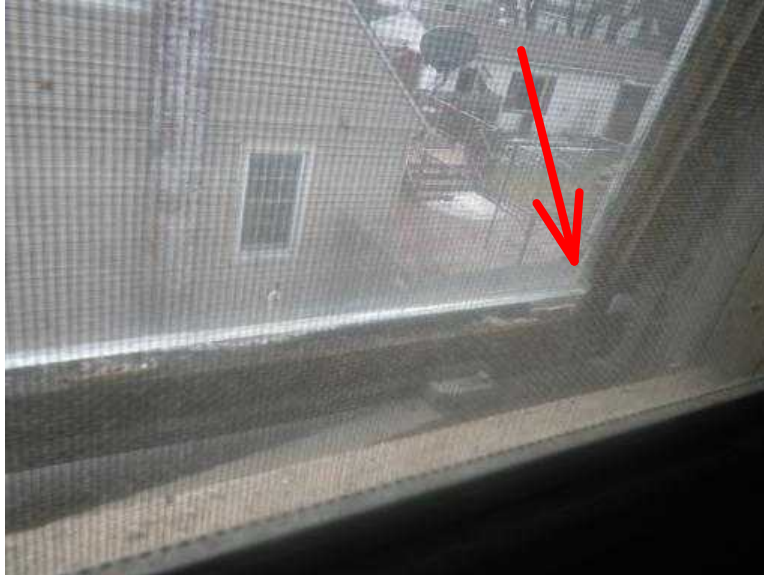
1. Acceptable Entry/Exterior Doors Entry/Exterior door hardware acceptable
2. Acceptable Interior doors Door hardware appears serviceable.
3. Repairs Recommended Windows Double hung, Sliding, Awning, Wood, Vinyl - [Control is damaged at upper bedroom window - South east bedroom - East window, Wood rot present at upper bedroom window - South east bedroom - South window](#)

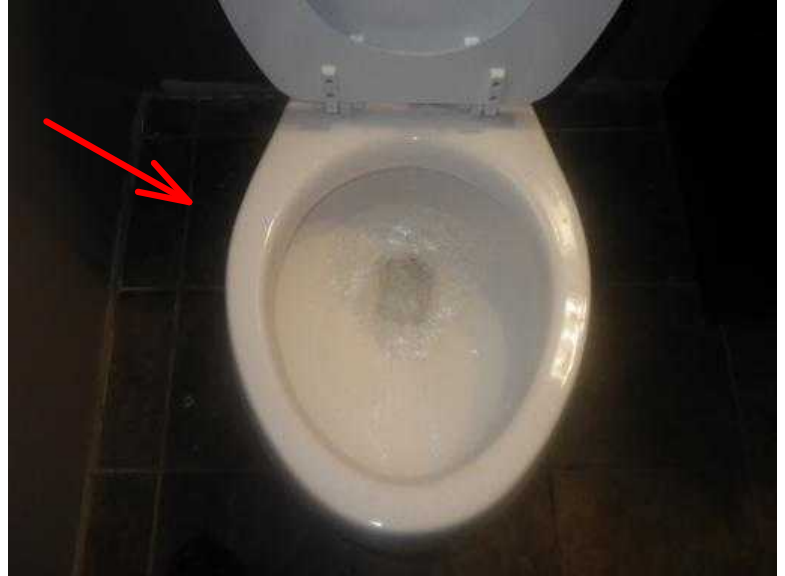
1. Repairs Recommended Toilet: Plumbing acceptable
- The toilet leaks at the floor, recommend replacement of the wax seal

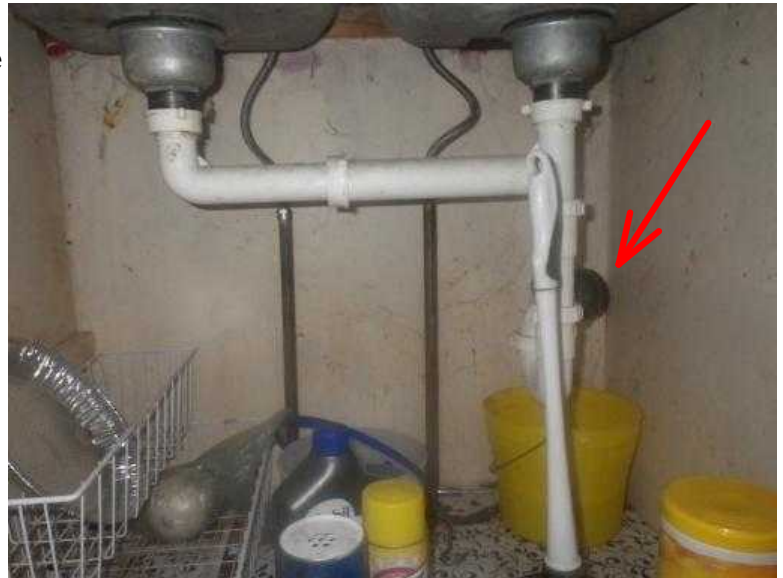
- 1. Acceptable Counter Tops: Laminate
- 2. Acceptable Cabinets: Wood
- 3. Acceptable Sink/Plumbing/Fixtures:
Faucet, plumbing acceptable
- Note - Evidence of past leakage present - Dry at time of inspection

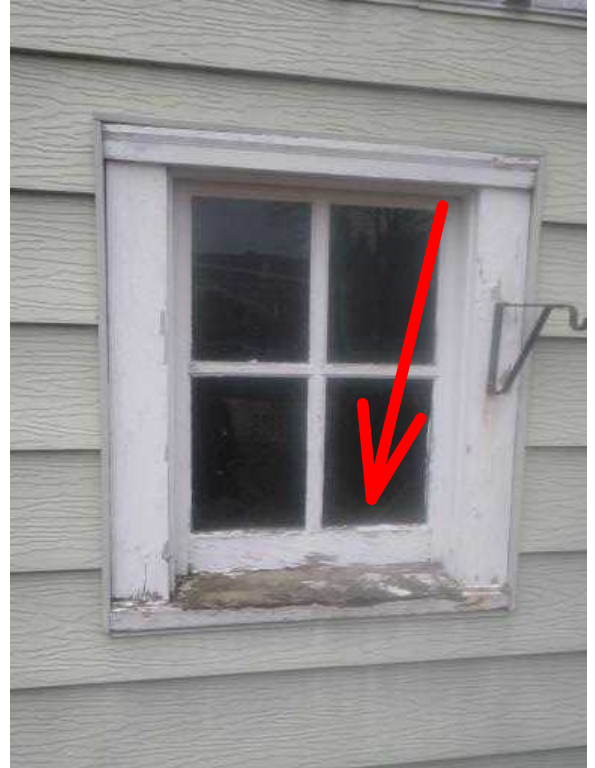
Trim, Soffit, Eaves: Wood, Metal, Common cracks - [Recommend painting wood trim as necessary to prevent moisture damage](#)

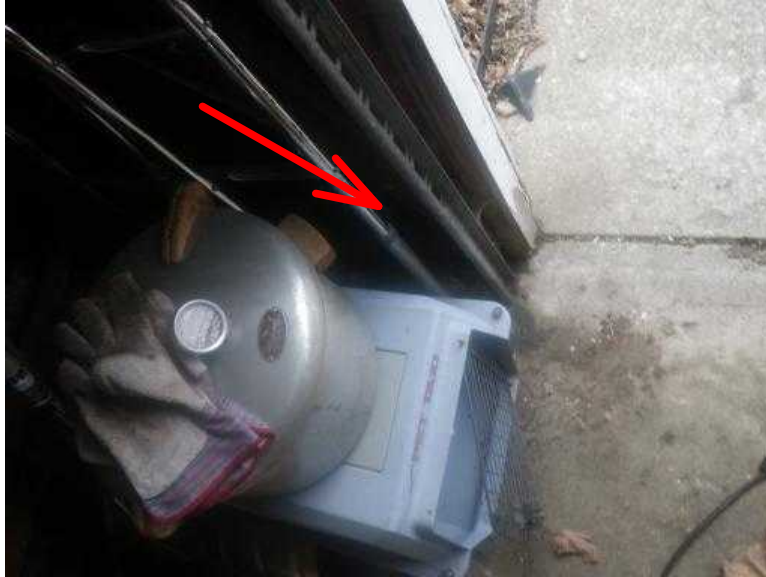
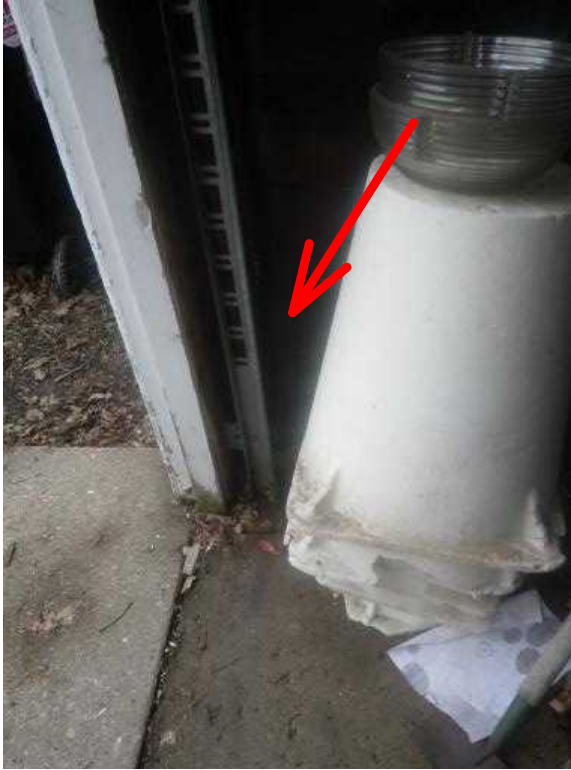
19. Repairs Recommended Door Opener: [Garage door opener does not meet current safety standards - No safety sensors](#)
